FATIGUE STRENGTH RESTORATION IN CORROSION PITTED 4340 ALLOY STEEL VIA LOW PLASTICITY BURNISHING

John T. Cammett* and Paul S. Prevey
Lambda Research, Cincinnati, OH

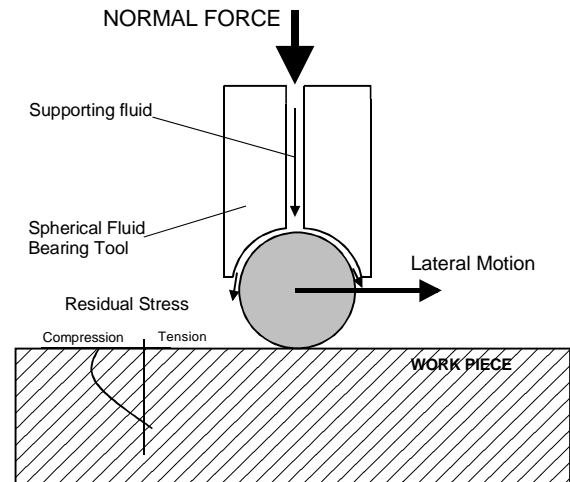
Figure 1 - Low Plasticity Burnishing schematic.

smooth free rolling spherical ball under a normal force sufficient to plastically deform the surface of the material, thereby creating a compressive layer of residual stress. The process is shown schematically in Figure 1. The ball is supported in a fluid bearing with sufficient pressure to lift the ball off the surface of the retaining spherical socket. The ball is in mechanical contact only with the surface to be burnished and is free to roll on the surface of the work piece.

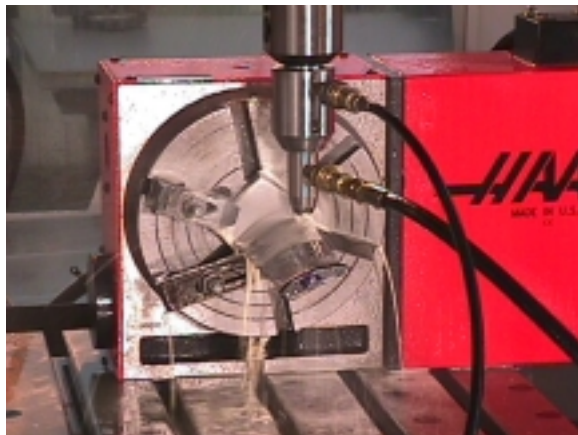
Figure 2 - LPB tool being used in four-axis mode while performing LPB on a compressor blade in a 20 HP vertical CNC mill.

The LPB tool designed to fit a CAT-40 tool holder in a Haas 20 HP vertical CNC mill is shown in four-axis operation in Figure 2. The quill of the machine is not rotated. The swivel links in the hydraulic hose allow exchange of the

tool to and from the tool holder so that LPB processing can be incorporated into standard machining sequences in existing CNC machine tools. Injection of the fluid through the quill of the mill is also possible in a suitably equipped machine. With minor modification, the apparatus can be adapted to most horizontal and multi-axis mills, or lathes.

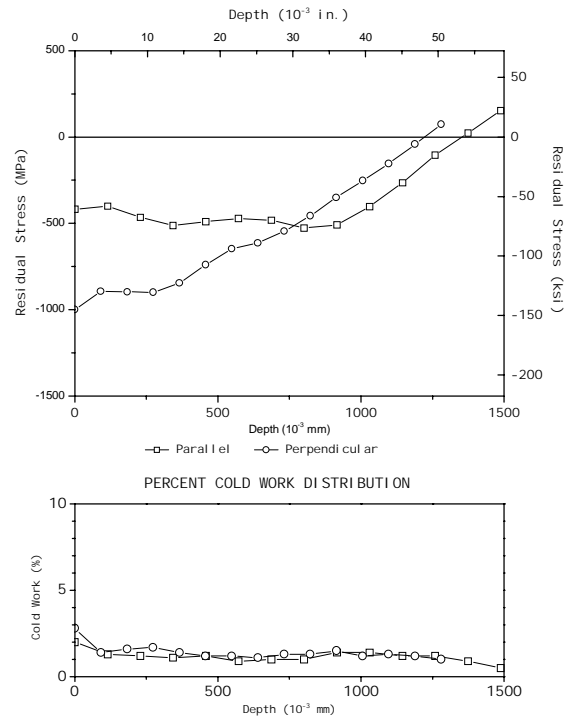
Figure 3 - Residual stress-depth and percent cold work-depth distributions produced by LPB (4340 Steel).

Figure 3 shows typical residual stress-depth distributions developed by LPB of the 4340 alloy steel, 38 HRC in this investigation. LPB parameters were developed using Taguchi analysis in a designed experiment to optimize compressive residual stresses and total depth of compression.²¹

Residual stress-depth results in Figure 3 show differences based on orientation to the direction of ball travel. As has been experienced in other LPB work^{9,10} by the authors, greater compression is developed perpendicular to the ball path than parallel to the ball path at the surface and to a considerable depth below. At greater depths the relative compression magnitudes were opposite while the depth of compression was greater parallel to the ball path. These effects occur as a result of the directionality of plastic deformation created in the LPB process. Overall the depth of compression in both directions, 1.2 - 1.4 mm (0.05-0.06 in), was at least three times greater than can normally be achieved via shot peening a material of this hardness at 0.25-0.38 mm (0.010-0.014 in) A intensity²².

The ball travel direction in the current work was always perpendicular to the specimen longitudinal plane of symmetry. Thus, the component of greater compressive residual stress magnitude was oriented in the same direction as the principal applied stress during bending fatigue testing.

Also shown in Figure 3 is the cold work-depth distribution resulting from LPB. As may be seen, the amount of cold work was generally small (< 3%) as is desirable in LPB. The maximum cold work at the surface was only very slightly greater than at any subsurface depth.

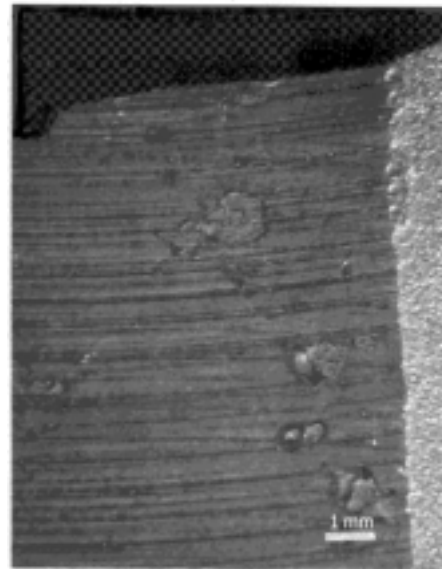
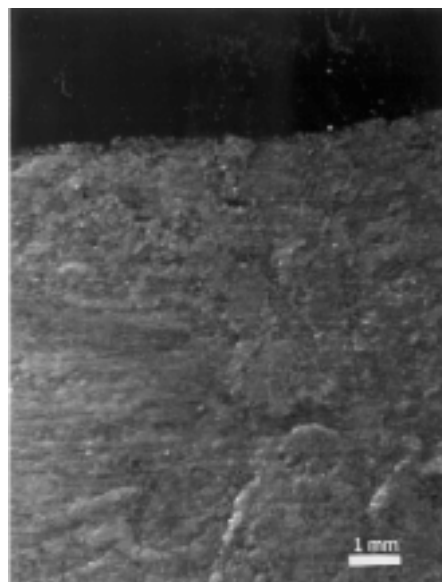
Figure 4 - Typical surface appearance after salt fog exposure.

Optical examination of salt fog corroded surfaces revealed generally that only slight general corrosion and pitting, typically 0.05-0.10 mm (0.002-0.004 in) deep, had occurred after 100 hour exposure. After 500 hour exposure, severe general corrosion and pitting, typically 0.12-0.25 mm (0.005-0.010 in) deep, had occurred. Figure 4 shows macrophotographs of typical surfaces after 100 and 500 hour salt fog exposures.

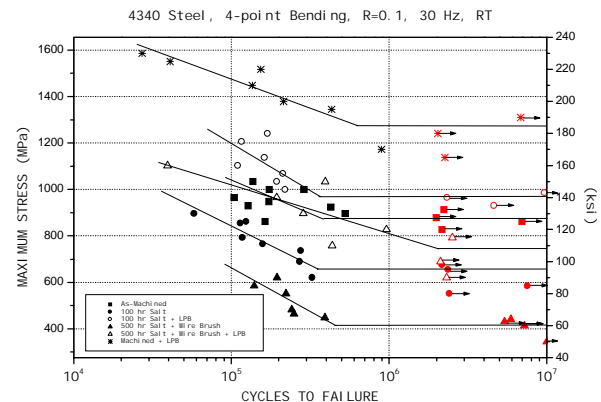
Figure 5 - High cycle fatigue S/N Data

Figure 5 shows fatigue S-N curves generated from specimens having six different surface conditions. These were:

As machined (end milling-end cutting)
Machined + LPB
Machined + 100-hr. salt fog exposure
Machined + 100-hr. salt fog + LPB
Machined + 500-hr. salt fog exposure
Machined + 500-hr. salt fog + LPB

As seen in Figures 4 and 5, LPB treatment increased long-life fatigue strength approximately 30 percent relative to the as machined condition at all cyclic lives. This increase is attributed to delay in crack initiation and retardation of fatigue crack growth by the residual compressive stresses induced in surface and subsurface layers by LPB.

As would be expected, corrosion on machined surfaces reduced fatigue resistance. As revealed in Figure 5, salt fog corrosion exposures greatly reduced fatigue strength relative to the machined condition at all cyclic lives. Fatigue strength reductions relative to the as machined condition of 30-35 percent and 45-55% were observed in specimens exposed for 100 and 500-hrs. respectively.

LPB treatment after corrosion exposure greatly improved the fatigue strength of corroded surfaces. For the 100-hr. exposed condition, the improvement was nearly 50 percent, giving fatigue strength at 10^7 cycles more than 10 percent greater than for the original machined condition. The 60 percent fatigue strength improvement by LPB for the 500-hr. exposed condition was also quite marked; however, the strength level after LPB remained 25 percent less than for the original as machined condition. Apparently, compressive stresses from LPB tend to delay and retard crack initiation and progression in corrosion damaged; however, not to the full extent exhibited by LPB treatment on a relatively undamaged, machined surface.

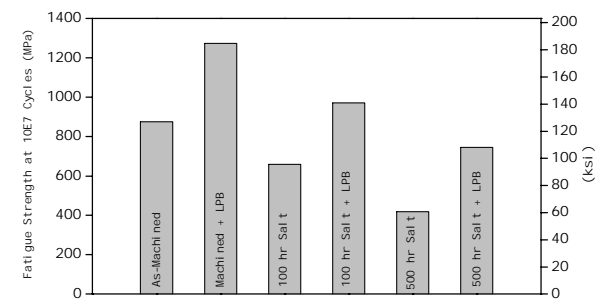
Figure 6 - Long life fatigue strength (4340 Steel).

For convenience in visualizing fatigue strength differences, maximum stress values at 10^7 cycles for each surface condition are presented in bar chart form in Figure 6.

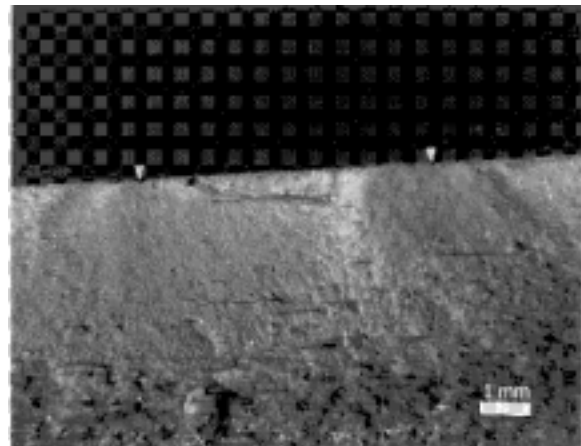
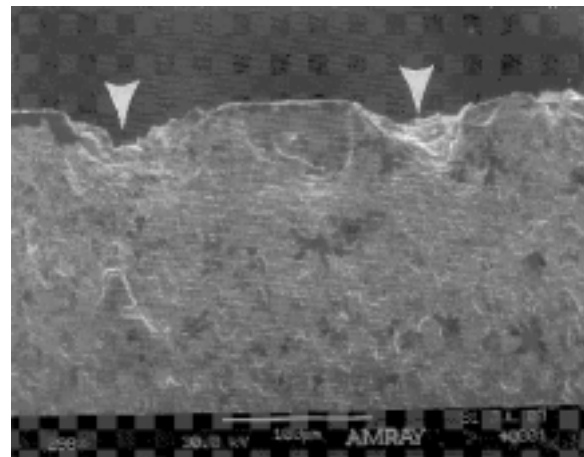
Figure 7 - Fatigue origins in two LPB treated, 100 hr. salt fog exposed specimens.

Fatigue fractures in all specimens were examined optically at magnifications to 40x to ascertain fatigue origin locations relative to processed surface areas and to determine if any extraneous features or anomalies had influenced failure. In general, all fatigue failures occurred within specimen gage sections and within representatively processed surface areas. All fatigue origins occurred at specimen surfaces insofar as could be observed optically. This is not surprising because the applied stress bias of the four-point bending, $R = 0.1$ testing mode would inherently favor surface fatigue origins. All machined and LPB treated machined specimens exhibited single fatigue crack origins. Multiple fatigue initiation sites were observed generally in salt fog corroded specimens and LPB treated corroded specimens. These sites were at corrosion pits even in the case of the LPB treated specimens despite their significantly

greater fatigue strengths relative to as corroded untreated specimens. This was in contrast to observations made in a previous similar investigation on 7075-T6 aluminum alloy¹⁰ wherein fatigue origins in LPB treated specimens occurred subsurface remote from corrosion pits having the same order of depths as those observed in the current investigation. In that previous work, full rather than partial restoration of fatigue strength from LPB after both 100 and 500-hr. exposures was achieved. From this it is apparent that not all degrees of corrosion damage in steel can be fully mitigated by LPB notwithstanding that pits were only 20 percent or less than the LPB depth of compression.

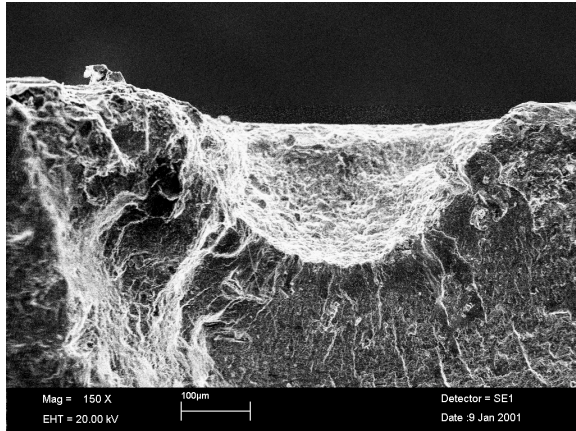
Figure 8 - Multiple microscopic fatigue origins from corrosion pit in LPB treated, 500 hr. salt fog exposed specimen.

A few specimens were selected for higher magnification fractographic observation via scanning electron microscopy (SEM). As-machined and LPB treated machined specimens exhibited single fatigue origins at specimen surfaces, confirming optical observations. No anomalous surface or subsurface features were noted. Also confirming optical observations, fatigue origins in as-corroded and LPB treated corroded specimens were from corrosion pits. Figure 7 is an exemplary micrograph of fatigue origins in an LPB treated, 100 hour exposed specimen. Corrosion pits were observed to be approximately hemispherical in shape. Figure 8 is an exemplary micrograph showing multiple fatigue initiation sites at the boundary of a pit in an LPB treated, 500-hr. exposed specimen.
